Safety Report

**National
Transportation
Safety Board**

NTSB/SR-15/01
PB2015-102744
Notation 8624
Adopted March 3, 2015

Commercial Vehicle Onboard Video Systems

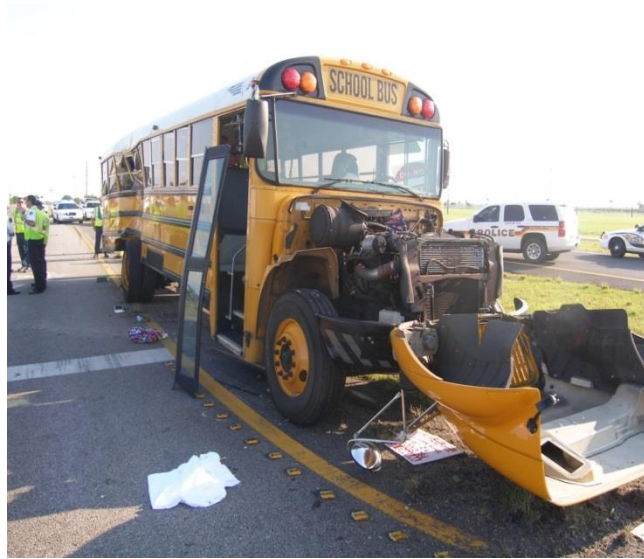
Figure 2. School bus, postcrash, at SR-70–CR-712 intersection, March 26, 2012.
(Source: Florida Highway Patrol)

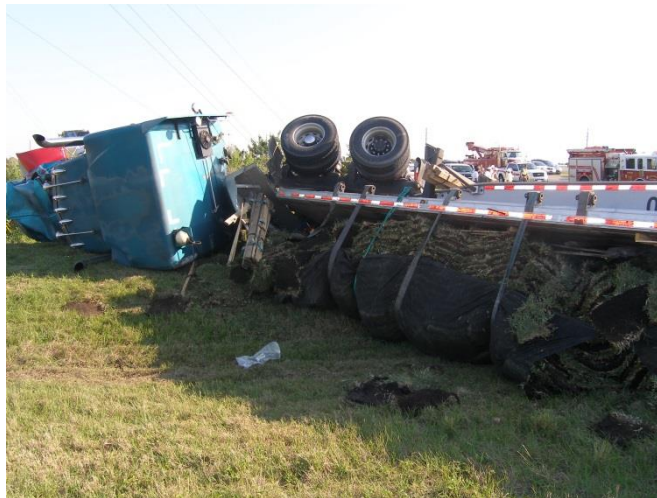
Figure 3. Truck-tractor semitrailer, postcrash, at SR-70–CR-712 intersection, March 26, 2012.
(Source: Florida Highway Patrol)

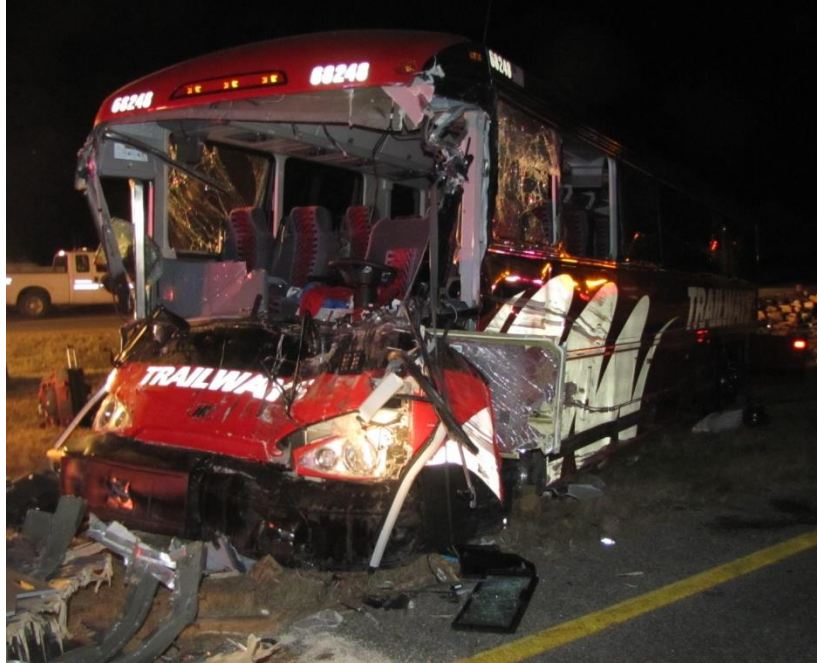
A short time later, two westbound commercial vehicles—a 1998 Kenworth truck-tractor semitrailer combination unit and a 2012 Motor Coach Industries Inc. (MCI) D4505 motorcoach operated by Burlington Trailways—came upon the overturned Volvo combination unit. The Kenworth truck was traveling in the right lane, and the MCI motorcoach had moved into the left lane to pass the truck. Shortly thereafter, the truck moved onto the right shoulder, sideswiping the Volvo's front bumper, and it then came to rest in the north ditch of the westbound lanes. After braking, the motorcoach collided with the overturned Volvo's semitrailer between the rear frame and the landing gear, separating it into two sections, and came to rest in the median (figure 4). The motorcoach had extensive front-end intrusion and deformation damage, as shown in figure 5.

Figure 5. Burlington Trailways MCI motorcoach postcrash. (Source: Nebraska State Patrol)

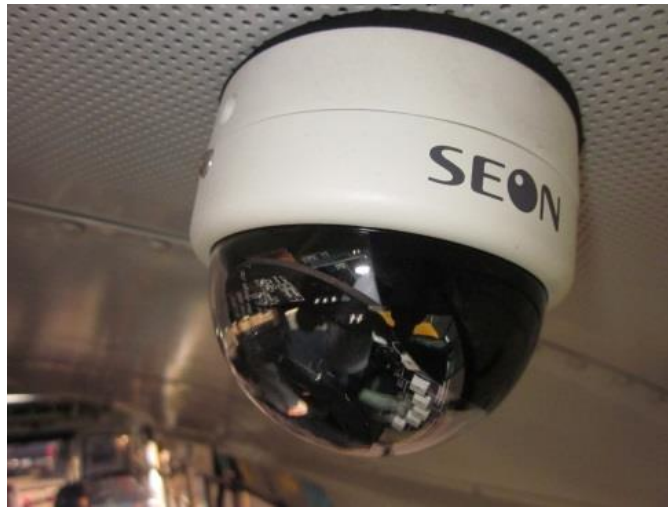
Figure 6 provides a close-up view of the interior Seon camera located at the back of the school bus. Figure 7 shows the positions of the three cameras located at the front of the bus. The four cameras collectively provided data on driver actions; the environment outside the bus (primarily from the first camera); and the interior environment, including passenger movements (primarily from the second, third, and fourth cameras).

Figure 6. Seon Design interior roof-mounted camera lens in Port St. Lucie school bus.

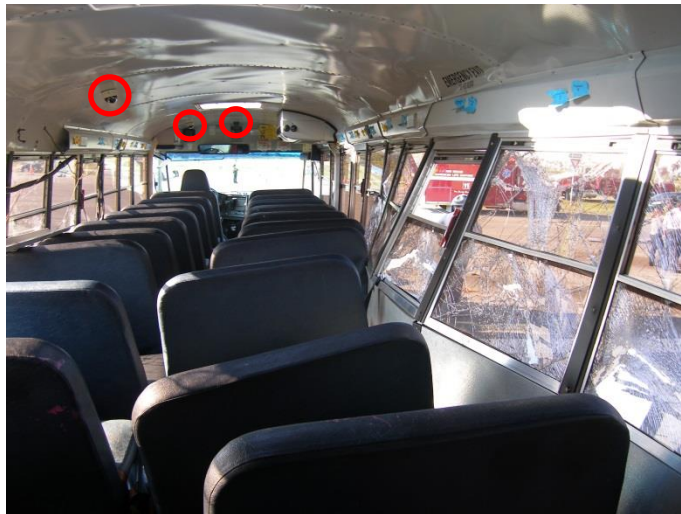
Figure 7. Interior of Port St. Lucie school bus, postcrash, showing locations of three Seon Design interior roof-mounted cameras (circled in red).

Because of the positioning of the cameras, neither the kinematics nor the final rest position of the fatally injured passenger was visible during the crash event or when the bus came to final rest. Observations of other bus occupants and the responding passerby provided limited information about this passenger. The NTSB concludes that though the continuous video system in the Port St. Lucie school bus documented critical postcrash information regarding passenger evacuation and LOC, it provided inadequate visibility of all passenger seating positions.
