Safety Report

**National
Transportation
Safety Board**

NTSB/SR-15/01
PB2015-102744
Notation 8624
Adopted March 3, 2015

Commercial Vehicle Onboard Video Systems

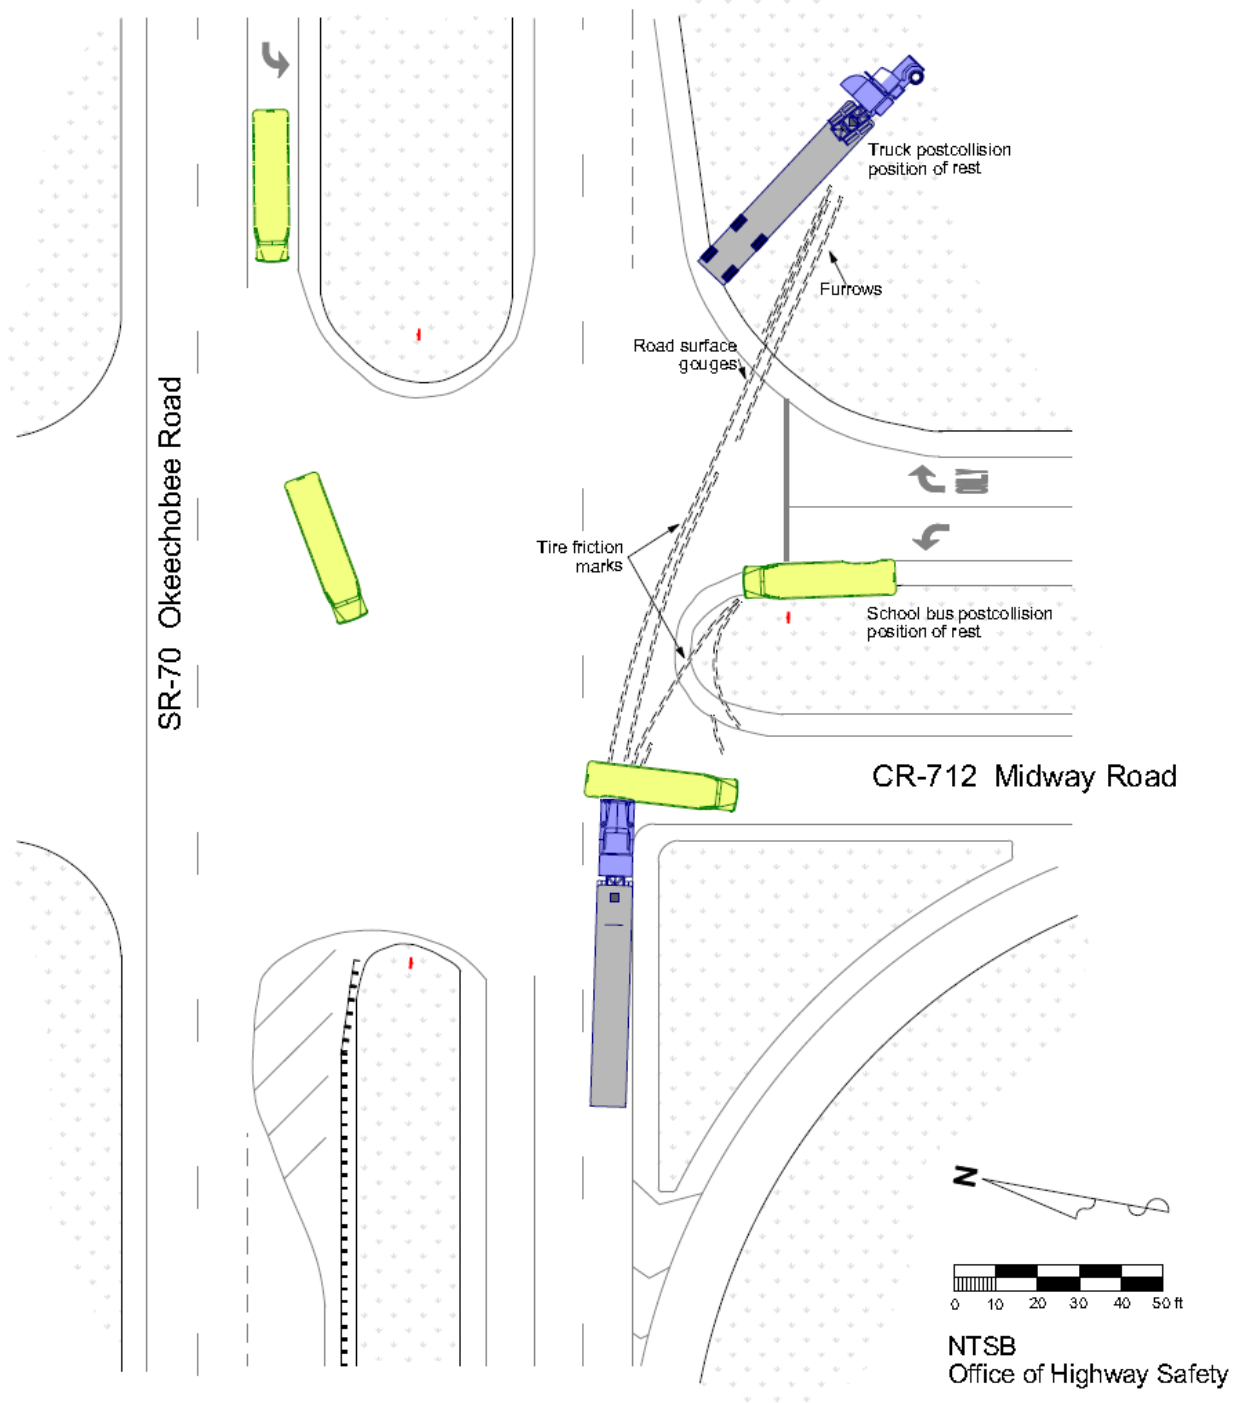
Figure 1. Port St. Lucie crash scene diagram based on accident reconstruction diagram provided by Florida Highway Patrol.

The school bus driver had entered a left-turn-only lane to travel across the center median and eastbound lanes onto Midway Road (County Road [CR]-712). The bus driver turned in front of the eastbound truck, which collided with the right side of the bus in the vicinity of the rear axle (figure 1). Following the impact, the school bus spun clockwise approximately 180 degrees and came to rest facing Okeechobee Road (figure 2). The truck departed the roadway onto the grassy right-of-way along the southeast side of the intersection and rolled to the left, coming to rest on its left side, with the trailer resting upside down (figure 3). As a result of the crash, one student on the bus was fatally injured. Eight students were seriously injured, 11 sustained minor injuries, and 10 were uninjured. The bus driver also sustained minor injuries. The operator of the combination vehicle refused medical treatment.

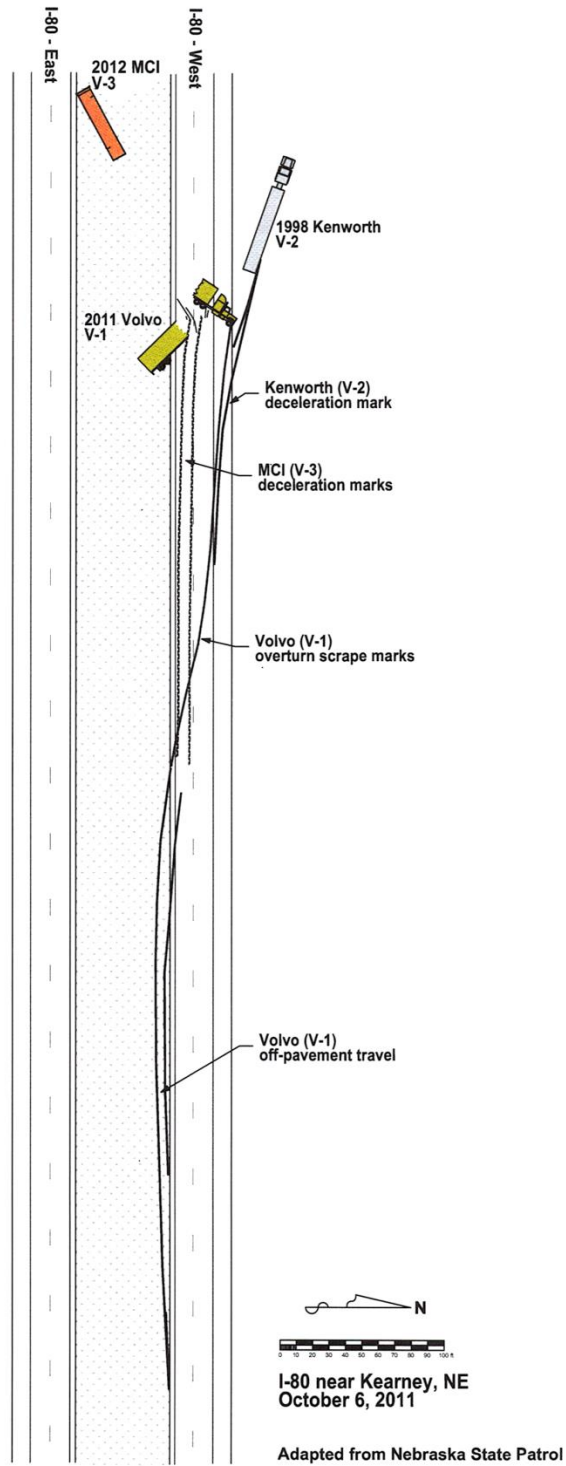
Figure 4. Kearney crash scene diagram depicting vehicle dynamics (adapted from Nebraska State Patrol diagram).

A short time later, two westbound commercial vehicles—a 1998 Kenworth truck-tractor semitrailer combination unit and a 2012 Motor Coach Industries Inc. (MCI) D4505 motorcoach operated by Burlington Trailways—came upon the overturned Volvo combination unit. The Kenworth truck was traveling in the right lane, and the MCI motorcoach had moved into the left lane to pass the truck. Shortly thereafter, the truck moved onto the right shoulder, sideswiping the Volvo's front bumper, and it then came to rest in the north ditch of the westbound lanes. After braking, the motorcoach collided with the overturned Volvo's semitrailer between the rear frame and the landing gear, separating it into two sections, and came to rest in the median (figure 4). The motorcoach had extensive front-end intrusion and deformation damage, as shown in figure 5.

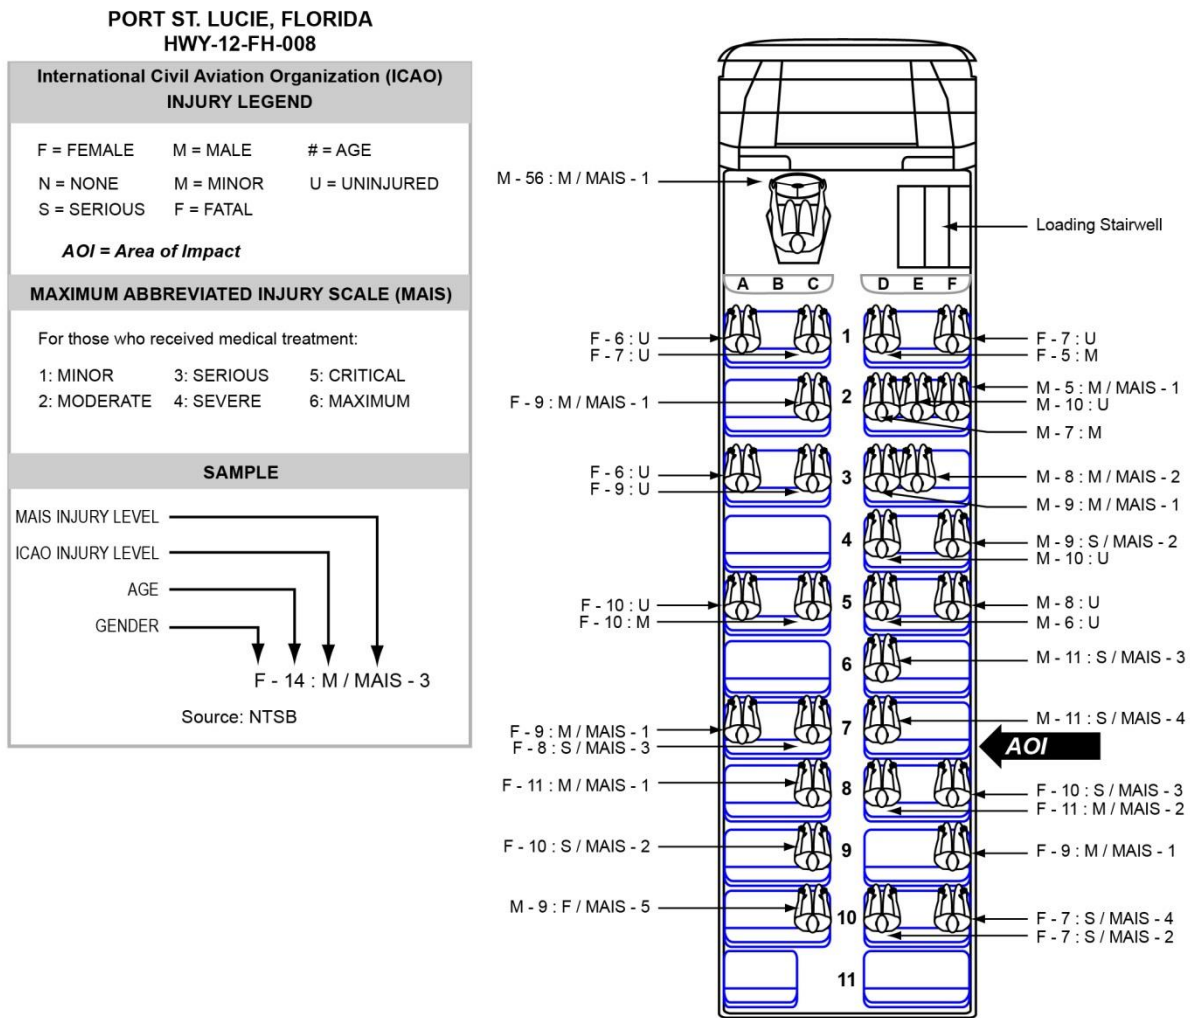
Figure 8. Port St. Lucie school bus passenger seating chart, with ICAO injury level, MAIS injury level, and demographic information.

Figure 8 shows the Port St. Lucie seating chart developed from the onboard video recordings. Injuries are marked in both the traditional International Civil Aviation Organization (ICAO) code and the comprehensive AIS.²⁴ Appendix D summarizes the Port St. Lucie occupant injury documentation.

Because of the length of the school bus and its rotation postimpact, occupant injuries vary according to the seating locations within the bus. The NTSB used video analysis software to quantitatively document the motion of the heads and pelvises of several occupants who were visible during the crash sequence, in addition to qualitatively describing the occupant kinematics throughout the event. As expected, based on the vehicle dynamics causing the bus to rotate approximately 180 degrees, head velocities and accelerations were greater for occupants seated toward the back of the bus than for those seated in the front. Pelvic velocities and accelerations were also higher toward the back of the bus, but lap belts provided pelvic restraint and reduced overall lower body motion.
